CENTRAL INTELLIGENCE AGENCY

SUBJECT **Finsterwalde Airfield**DATE DISTR. **August 28, 1956**NO. PAGES **1**REQUIREMENT
NO.**RD****25X1****PROCESSING COPY**DATE OF
INFO.PLACE &
DATE ACQ.

Miscellaneous Information on FINSTERWALDE
Airfield

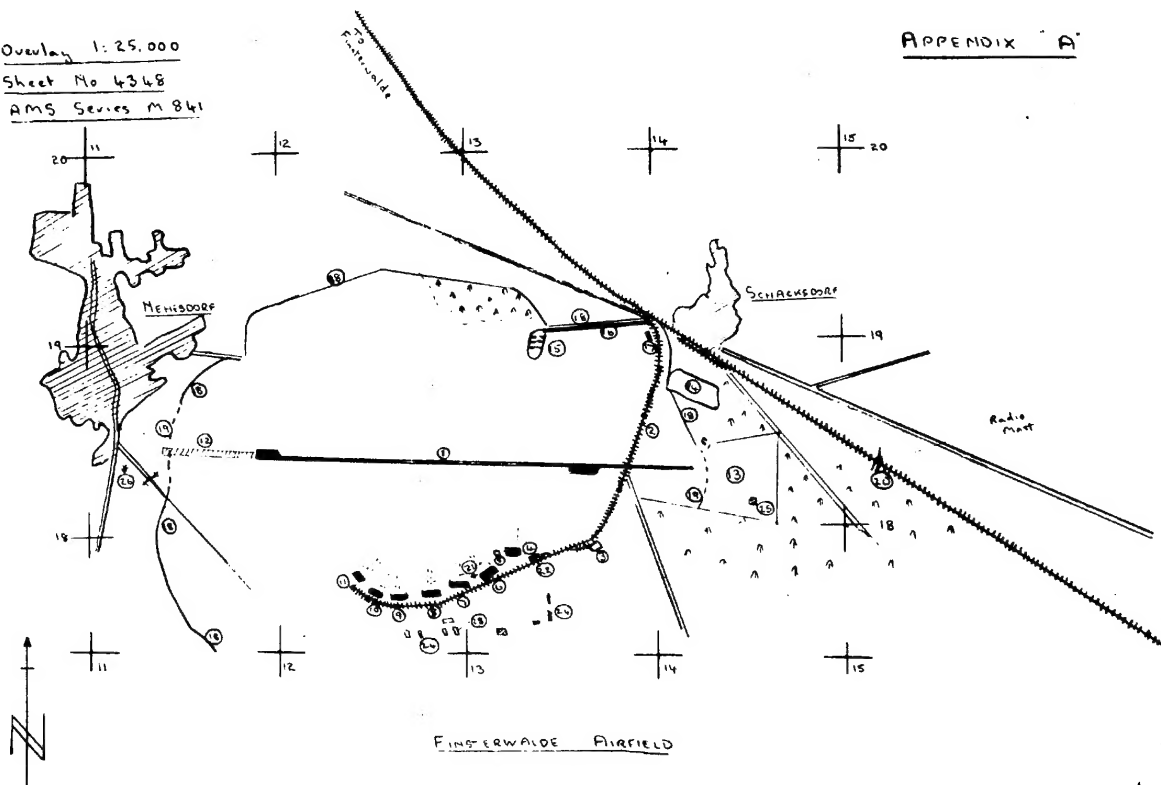
APPENDIX A

Attached at Appendix "A" is an overlay taken from local 1:25000 map, showing relative features of this airfield.

1. Concrete runway 2,300 m. in length and approx. 60m. in width.
2. Airfield rail spur.
3. Underground fuel storage installation and fuel discharge point.

4. Aircraft maintenance hangar.
5. Air traffic control tower.
6. Badly damaged hangar, roof mainly intact, but side walls blown out.
- 7 - 11. Five identical serviceable aircraft hangars, measuring approx. 85 m. x 50m. each having a shallow curved roof.

12. Cleared and levelled strip approx. 500m. x 100m.
13. Eastern approach funnel approx. 500m. in length and 500m. wide.
14. Brick works, wired and guarded and used as a prison camp.

15. Ammunition storage depot, comprising 6 identical brick built storage sheds.
16. Concrete approach road connecting ammunition depot to nearby rail spur.

17. Offloading ramp for ammunition depot.
18. Wooden perimeter fencing.
19. Barbed wire perimeter fencing.
20. Single masted radio station adjoining railway line.

21. Accumulation of fuel bowser lorries.
22. Railway station and main offloading ramp.
23. Main airfield kitchen block.
24. Series of 2 storage brick built barrack blocks.

25. Water drainage discharge point, constructed after runway was extended.
26. Unidentified radar installation.

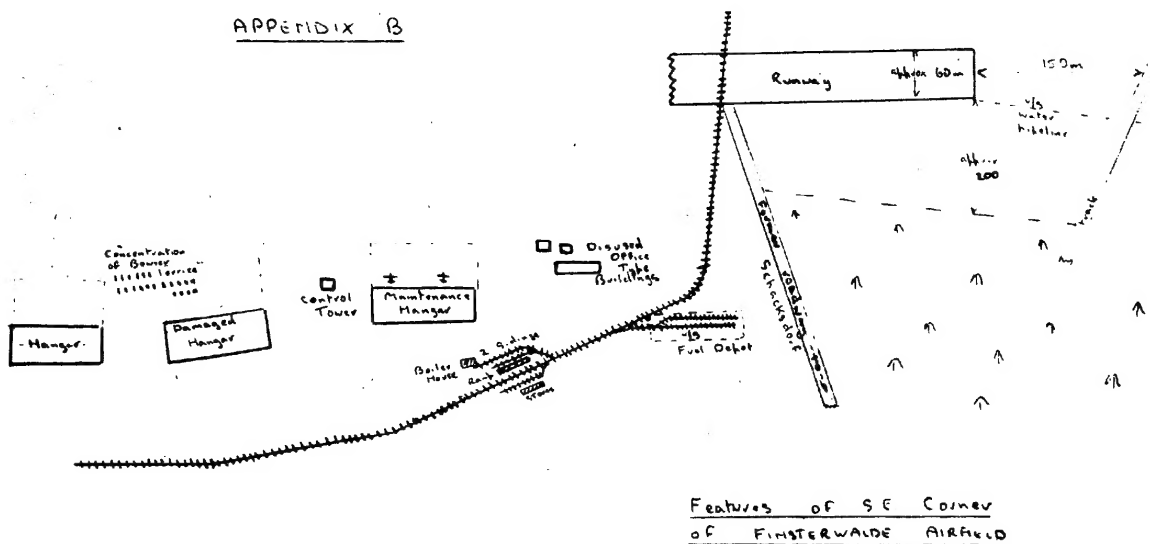
APPENDIX B

Attached at Appendix "B" is a rough sketch plan showing the relative layout of the main buildings in the SOUTH EAST corner of the airfield.

c) At MR 1340 1785, a series of sidings lead off WESTWARDS, the two sidings on the NORTHERN side adjoin an extensive offloading ramp and feed a nearby boiler house, whilst a further siding located on the SOUTHERN side of the rail spur feeds into a large barrack store.
